# Test Report

The fire resistance performance of a fully insulated, timber, single acting single door and a fully insulated, timber, single acting double door assembly when tested in accordance with BS EN 1634-1:2014+A1:2018 and two cable passthroughs tested with additional of guidance where practicable of BS EN 1366-3: 2021

Project ID 20221031-005814

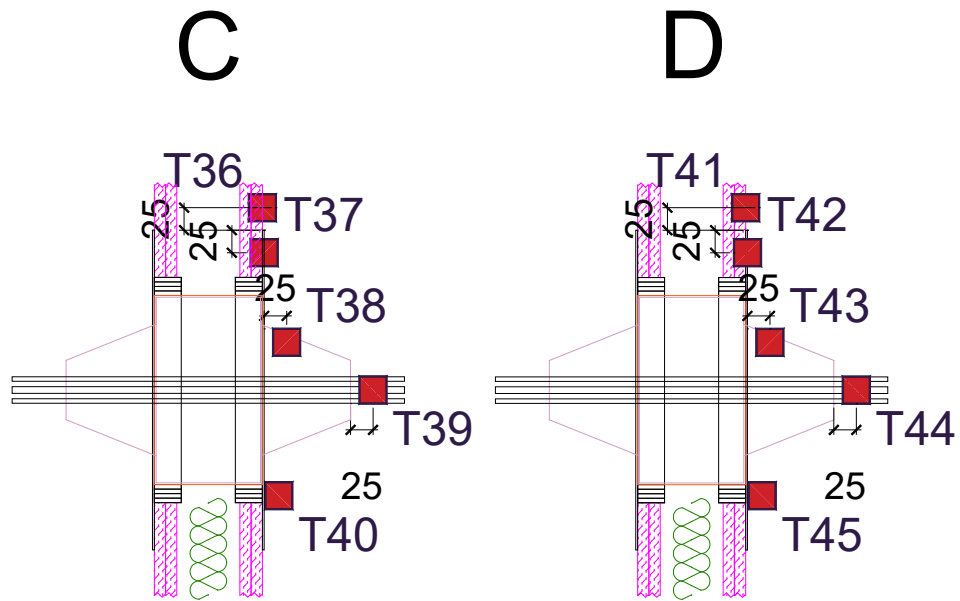
Figure 9 – Vertical layout of instrumentation on specimens C & D

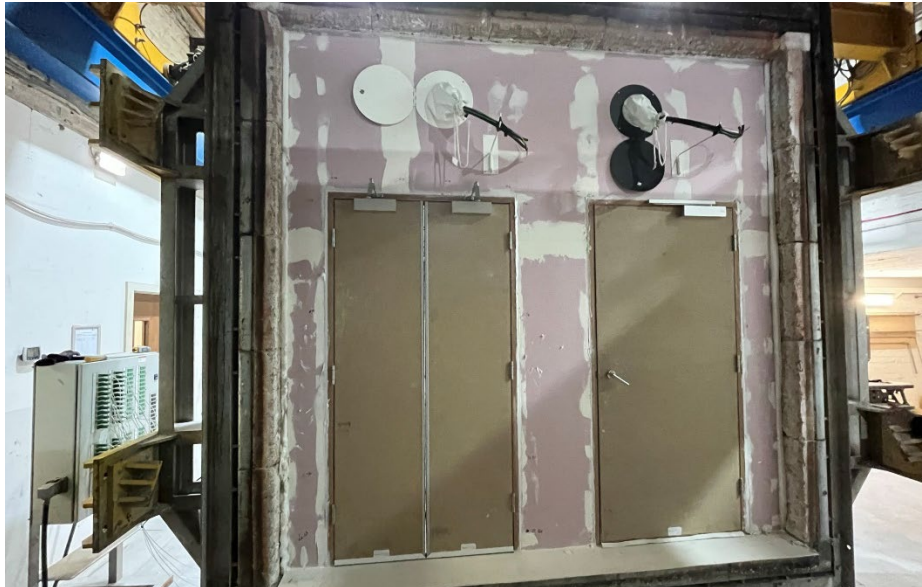
Figure 20 – The exposed surface of the test construction prior to commencement of the test

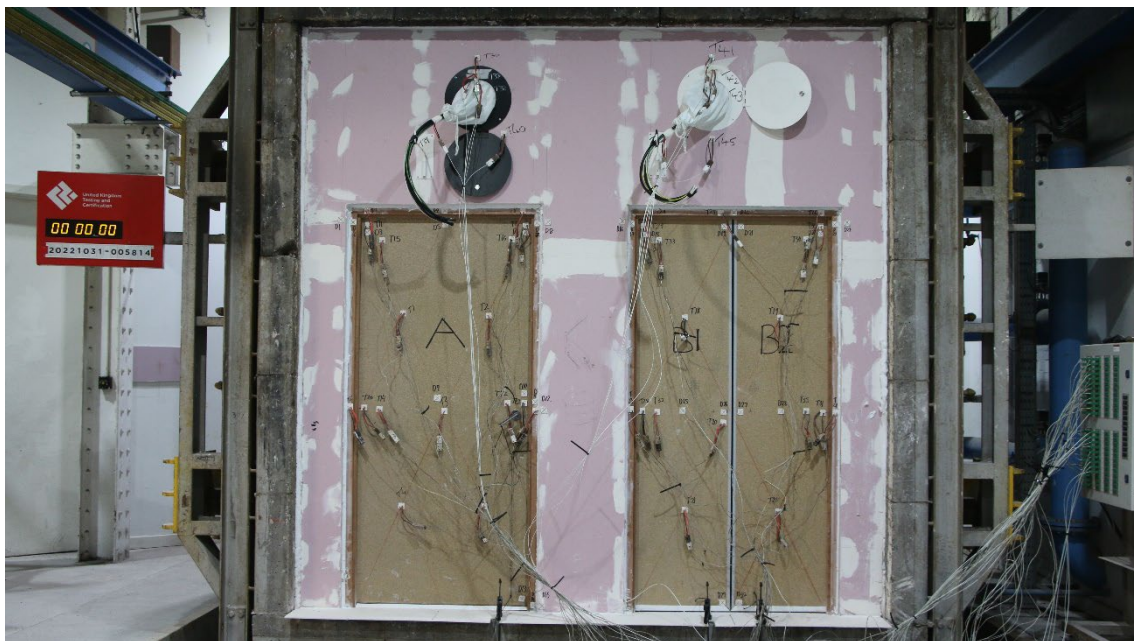
Figure 21 - The unexposed surface of the test construction prior to the commencement of the test

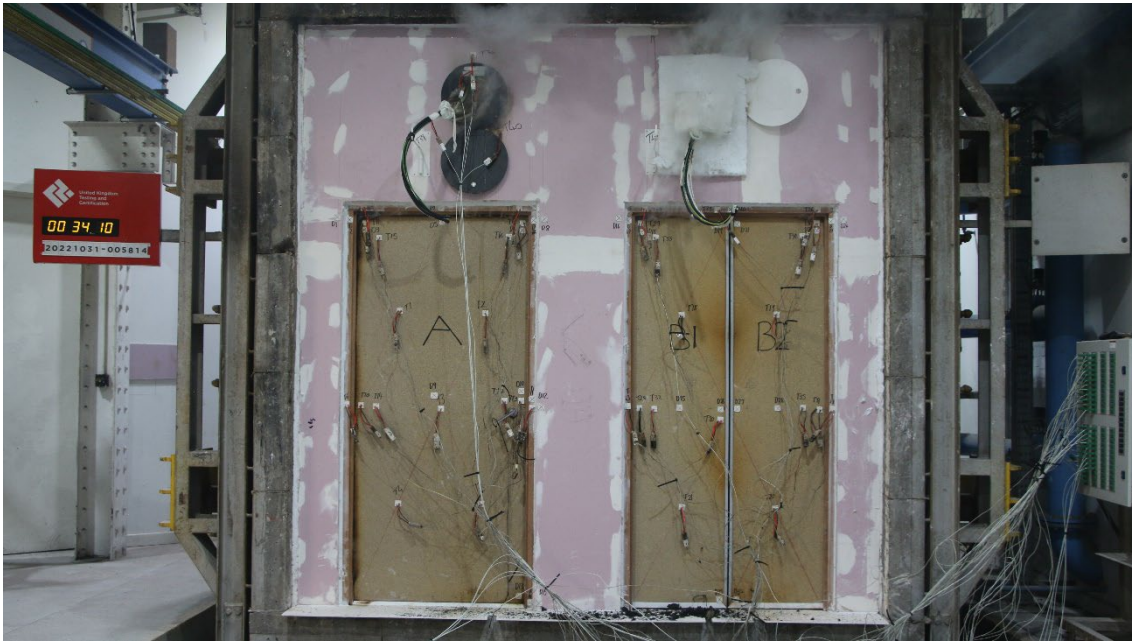
Figure 24 - The unexposed surface of the test construction after a test duration of 34 minutes

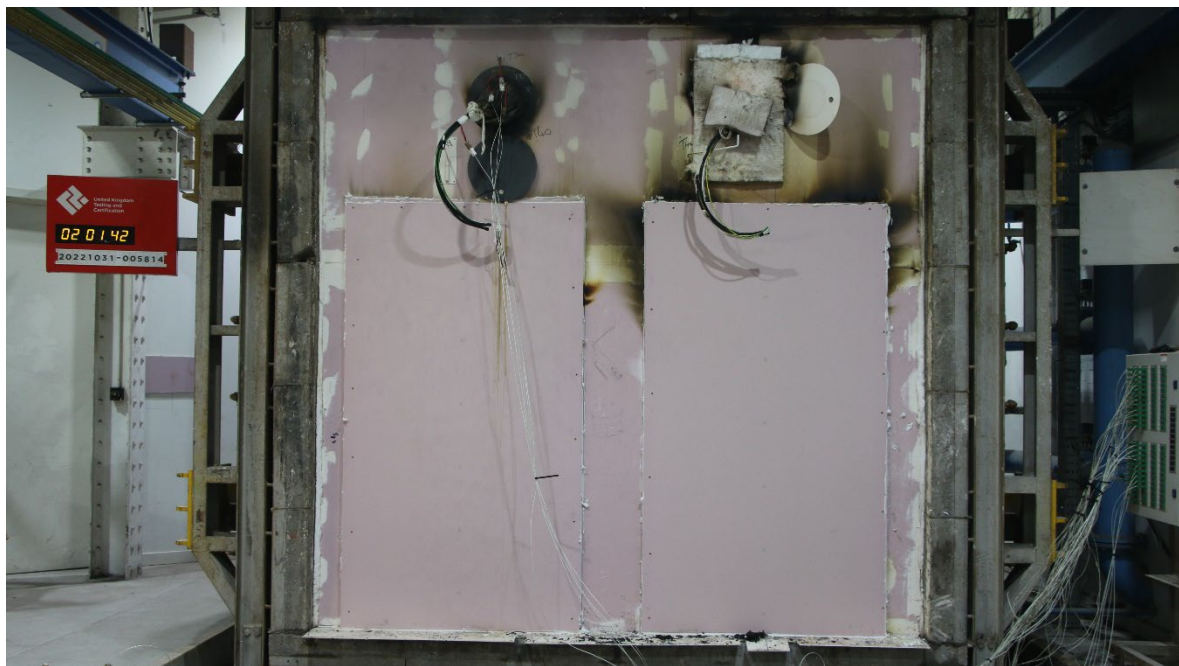
Figure 33 - The unexposed surface of the test construction after a test duration of 121 minutes

\*The test was discontinued after a period of 121 minutes.

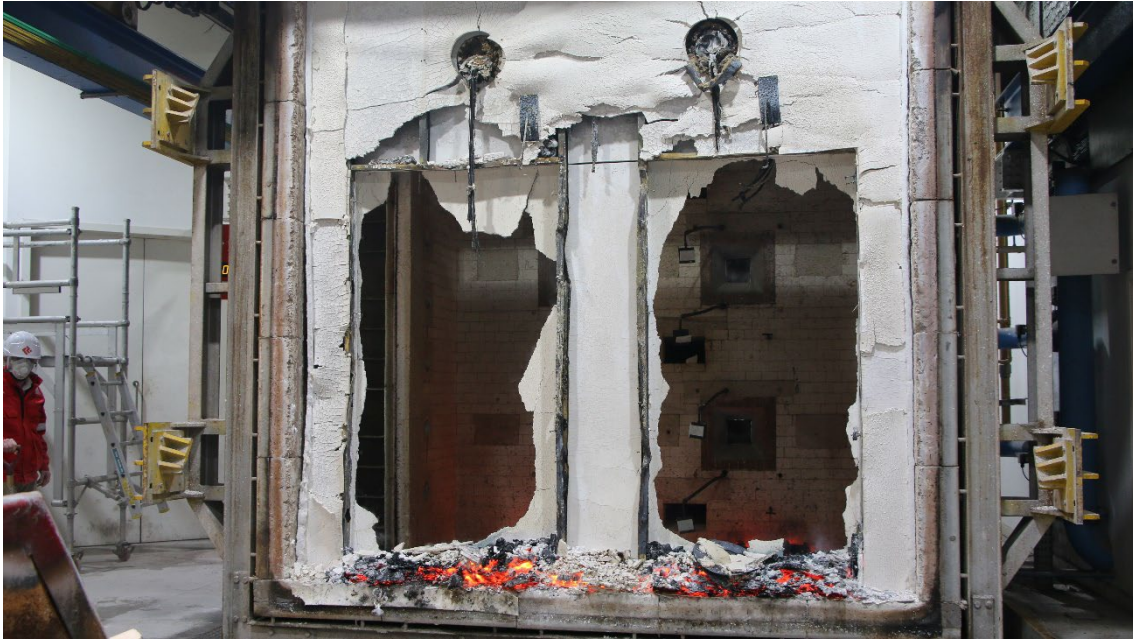
Figure 34 - The exposed surface of the test construction after the test was discontinued

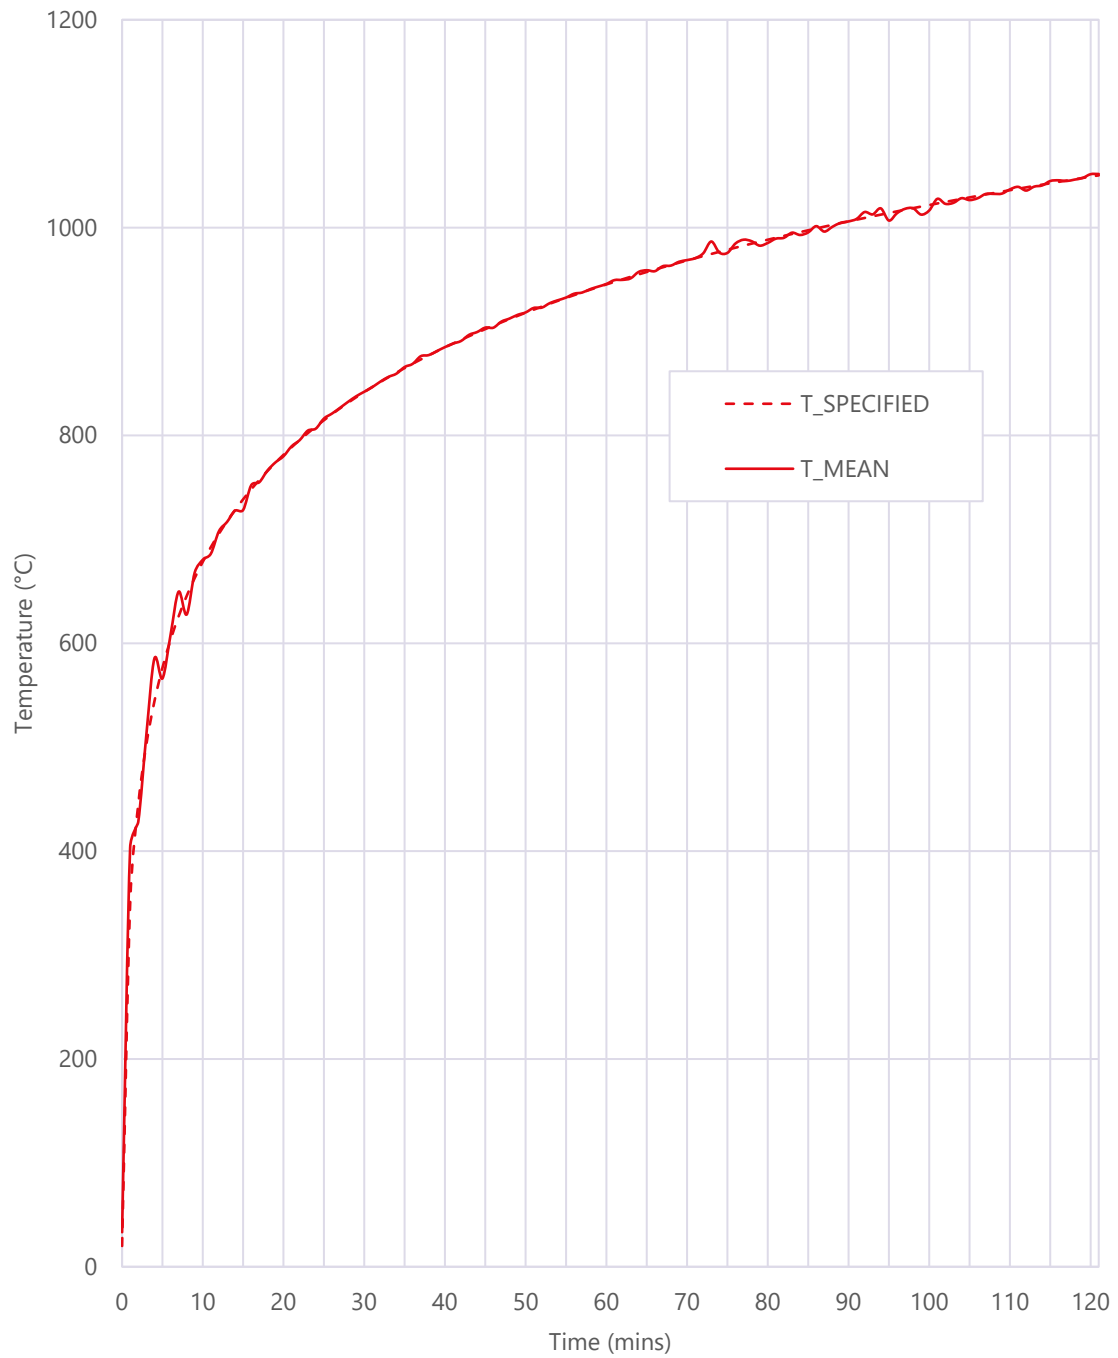
Figure 35 – Graph presenting the Time-Temperature distribution of the furnace

The specimens were subject to heating conditions in accordance with BS EN 1363-1:2020 § 5.1. This was monitored and controlled for the duration of the test using type K thermocouples which were distributed across a vertical plane  $100 \pm 50$  mm from the exposed surface of the test construction. The resulting Time-Temperature distribution is presented in Figure 35.
